TMS320F28075 Piccolo Microcontroller

Silicon Errata

Literature Number: SPRZ423D
October 2014–Revised July 2016

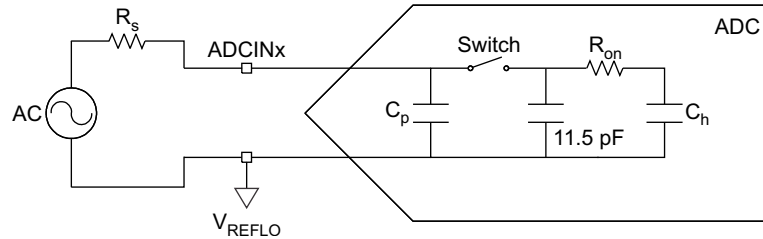
Figure 3. Single-Ended Input Model

The ADC input model should be used to select the sample-and-hold (S+H) duration for each ADC input. For the revisions affected, if the currently converting channel is an even-numbered channel and the previously converted channel was an odd-numbered channel (or vice versa), then the 12-bit input model will not accurately predict ADC input performance. Under these conditions, an additional capacitance should be added to the model. This capacitance has a value of 11.5 pF and should be placed between the S+H switch and R_{on} as shown in Figure 3.

For the revisions affected, when subsequent conversions switch between channel groups, the S+H duration should be chosen to account for the additional capacitance.
